TECHNICAL INFORMATION OF CHANGE

PROJECT: Micro-Q

TIOC #: 15 / 001120

SUBJECT: Ellimination of hum on phones output

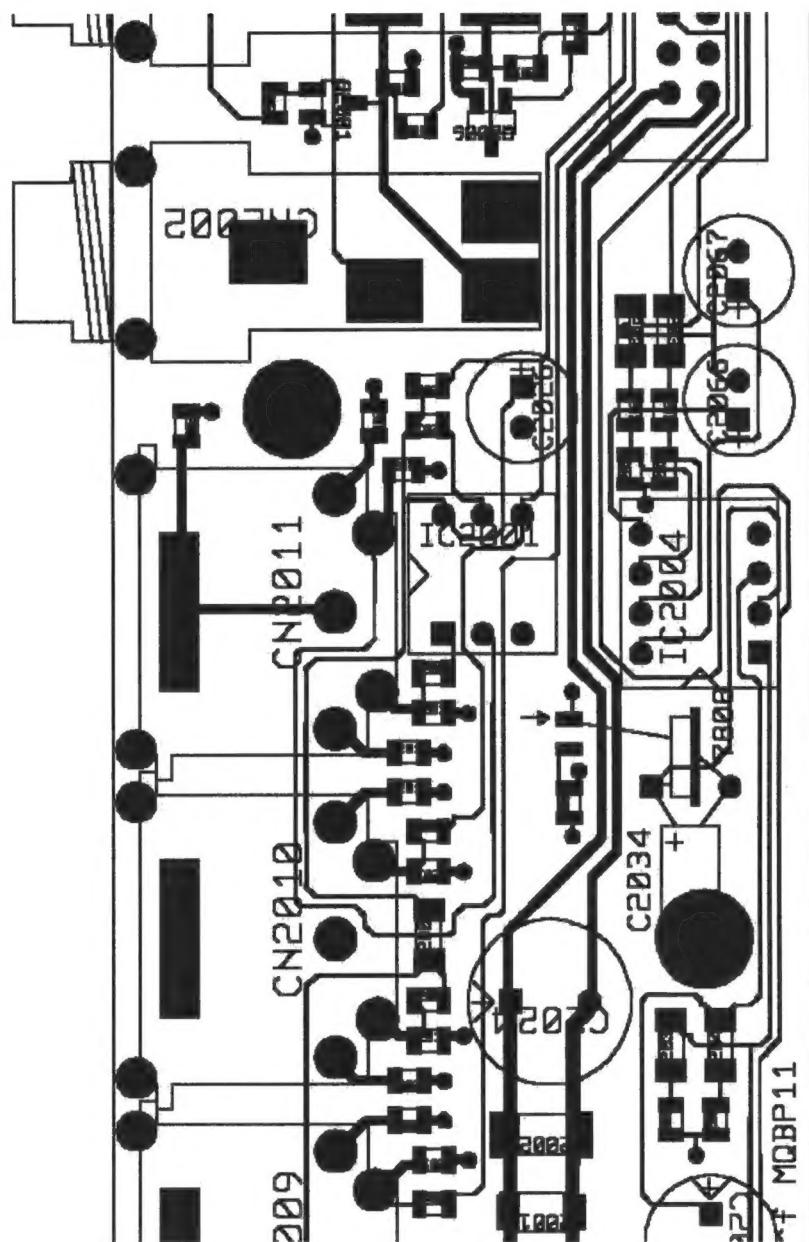
SHT 3 OF 4

Audible hum on the phones output is caused by a high ripple on the power supply voltage. There are 2 ways to solve this problem:

Changed Values:

Part Name	Old Value	New Value	Schematic Page
C2034	470u	10u/50V	3 / B4

Omitted Parts:

Part	Value	Description	Schematic Page
R2022	10R		3 / B4

New Parts:

Part	Value	Description	Schematic Page
IC1209	7808	Regulator TO220	3 / B4

Modify-Procedure:

Replace the 470u cap by 10u cap. The length of the 10u cap leads should kept that long, that the solder pads are accessible on the component side to mount the regulator piggyback style.

Remove the smd resistor.

Solder the 7808 terminals (In,GND,Out) the following way:

In: solder to right pad of the removed R2022 (which points to the flat cable)

GND: solder to the - Pin of C2034

Out: solder to the + Pin of C2034.
